Re: Major Municipal; SIC 4952; Compliance Evaluation Inspection; Bloomfield Wastewater

Treatment Plant; NPDES Permit No. NM0020770; May 12, 2015.

# City of Bloomfield WWTP NPDES Permit Number NM0020770 Compliance Evaluation Inspection May 12, 2015 Page 1 of 5

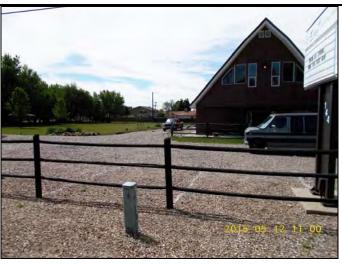
#### MED/SWQB Official Photograph Log Photo #1 & 2

The April 15, 2015 Sewer Overflow at 1441 East Blanco Blvd., an estimated 750 gallons was reported. Sewage flowed through at least one business and one resident's property.

Subject: Location of April 15 sewer overflow, 1441 E. Blanco Blvd. and a property that was affected. The property is subgrade from the sewer line. The area was clean and free of the debris at the time of the in section. The building is under construction for repairs from sewage damage.

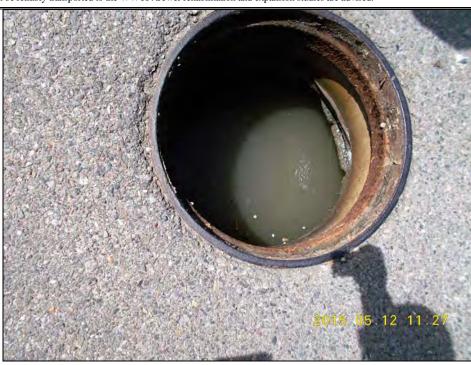
#### NMED/SWQB Official Photograph Log Photo #3

April 21, 2015 Sewer Overflow at the high school stadium parking lot, an estimated 300 gallons was reported. Some raw sewage did likely enter a storm drain that flows to the San Juan River though the exact volume is unknown.

Subject: Manhole at the high school stadium parking lot. The flow level is less than 2 feet below the surface and the sewer line is at capacity. No additional flow in this part of the collection system can be reliably transported to the WWTP. Sewer rehabilitation and expansion studies are advised.

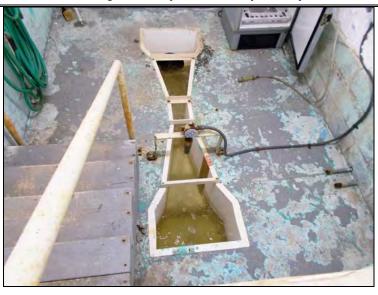
- 7. Chlorine Contact Chamber Floating solids were observed in the chamber. Operators have installed a surface baffle to catch floating solids on the surface before they reach the effluent discharge point. In addition, since the last inspection, screens have been installed to catch all floating solids before leaving the treatment unit. This has improved effluent quality and has reduced the amount of visible floating solids being discharged.

NMED/SWQB Official Photograph Log Photo # 4						
Photographer: B. Cooney	Date: May 12, 2015	Time: 13:20 Hours				
City/County: Bloomfield / San Juan County  State: New Mexico						
Location: Bloomfield Wastewater Treatment Plant						
Subject: Effluent Parshall Flume – the e	ffluent was free of floating solids – an improvement from the	previous inspection.

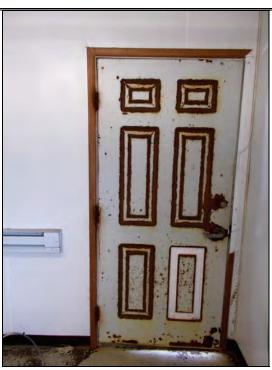
NMED/SWQB Official Photograph Log Photo # 4						
Photographer: B. Cooney	Date: May 12, 2015	Time: 13:23 Hours				
City/County: Bloomfield / San Juan County State: New Mexico						
Location: Bloomfield Wastewater Treats	ment Plant

- 8. The dechlorination solution, liquid sodium bisulfite is stored in the enclosed shed where the effluent sampling Parshall flume is located. Strong odors of the solution and extensive corrosion of all the metal piping including deterioration of the shed door suggest this storage does not provide adequate containment to protect workers and environment. This is potentially a hazardous situation for workers and this report is being sent to OSHA in New Mexico for review.

Subject: The metal door in the building that houses the effluent Parshall flume and the dechlorination storage solution sodium bisulfite is showing signs of corrosion from the vapors.

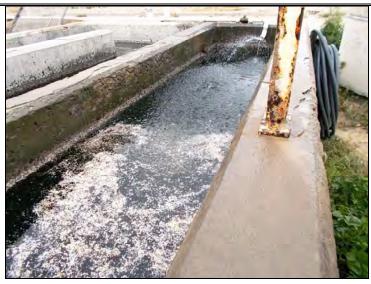
- 3. Secondary Clarifiers -The surface skimmer is worn and is not aligned correctly. It is pushing floating solids over the weirs and to the chlorine contact chamber. (This is a repeat finding)

NMED/SWQB Official Photograph Log Photo #5						
Photographer: B. Cooney	Date: May 12, 2015	Time: 13:25 Hours				
City/County: Bloomfield / San Juan County  State: New Mexico						
Location: Bloomfield Wastewater Treatment Plant						
Subject: Extensive solids entering the cl	alorine contact chamber.

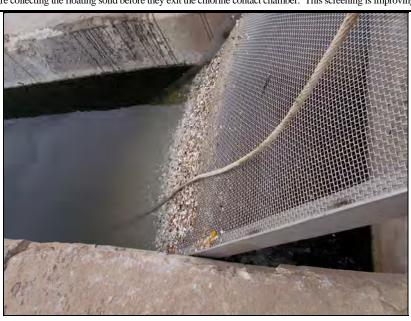
NMED/SWQB Official Photograph Log Photo # 6						
Photographer: B. Cooney	Date: May 12, 2015	Time: 13:24 Hours				
City/County: Bloomfield / San Juan County  State: New Mexico						
Location: Bloomfield Wastewater Treatment Plant						
Subject: Newly installed screens are coll	Subject: Newly installed screens are collecting the floating solid before they exit the chlorine contact chamber. This screening is improving the effluent quality.
